# ARM Group Inc.

Re: Pre-Demolition / Pre-Renovation  
Inspection Report  
NoHo Pilot Project  
411, 413, and 415 North Howard Street  
Baltimore City, Maryland  
ARM Project M11130

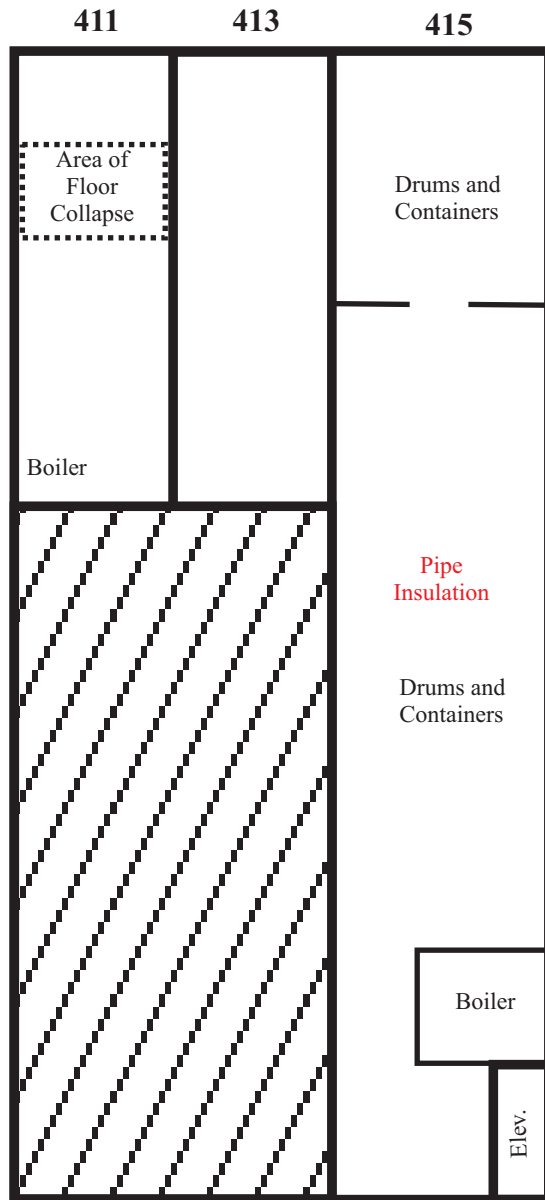
**Figure 2a**

**Site Plan - Basement**

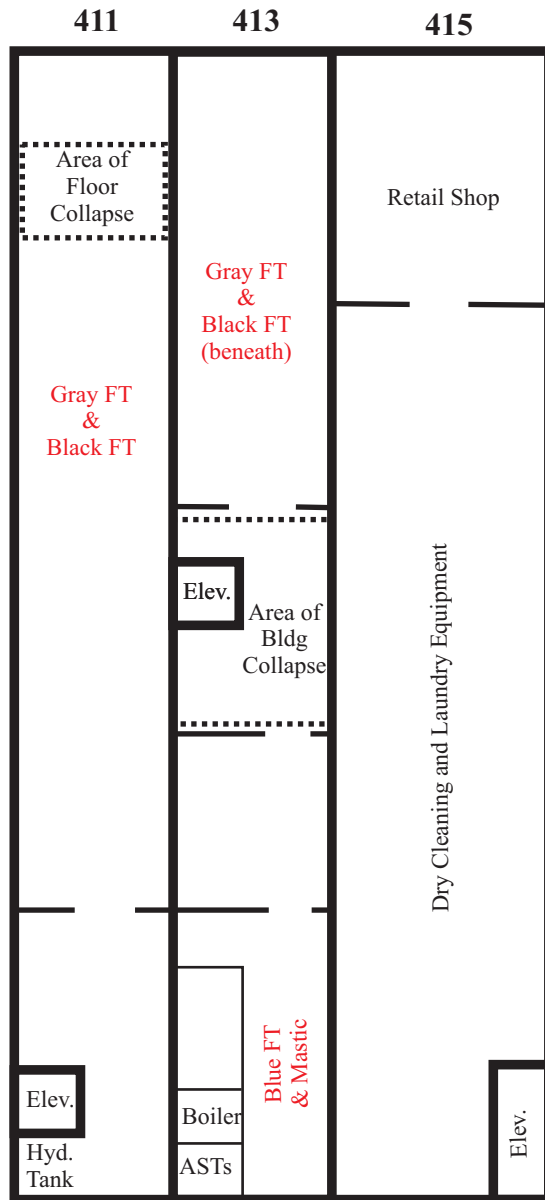
**Figure 2b**

**Site Plan - 1st Floor**

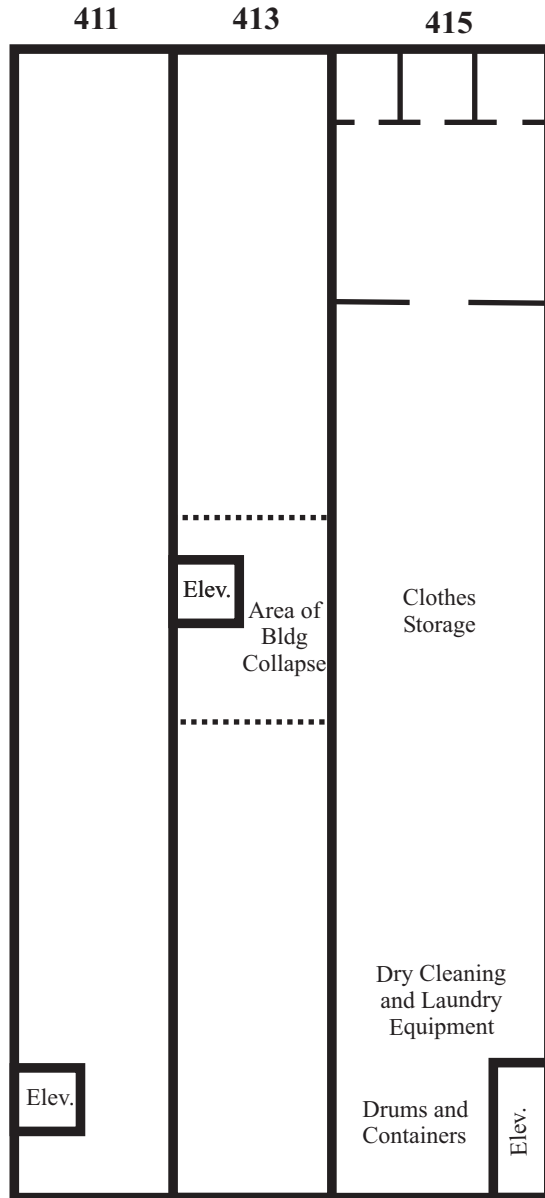
Figure 2c

Site Plan - 2nd Floor

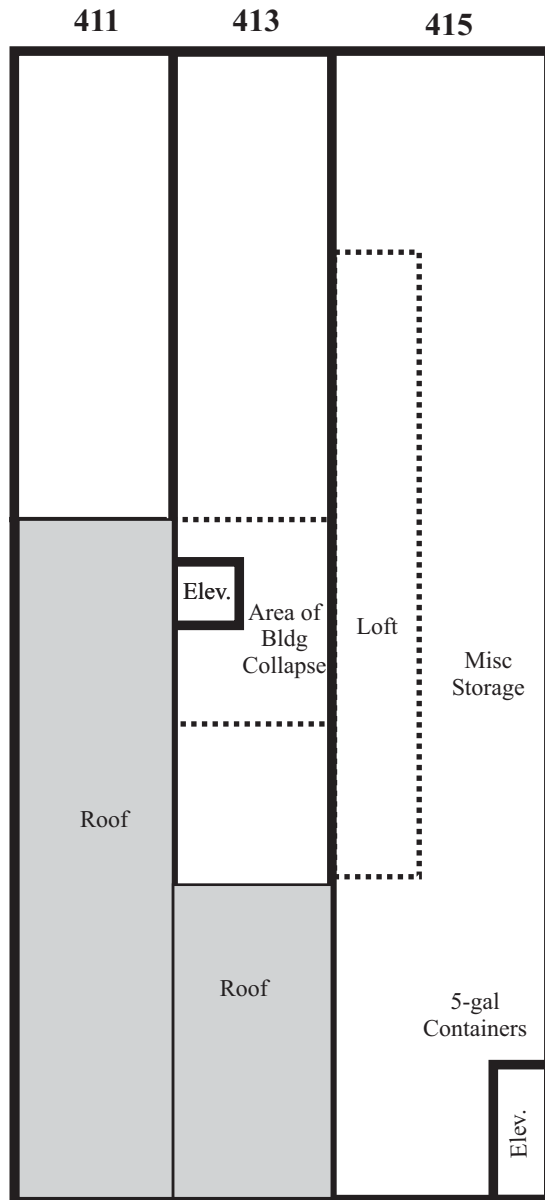
**Figure 2d**

**Site Plan - 3rd Floor**
